Inspection Report

Sample Street
NY

Premier Inspection Services

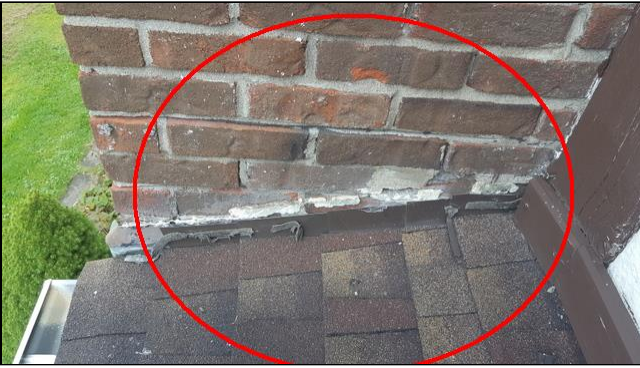
1.1 Item 1(Picture) Missing counter flashing

- (1) Counter flashing is missing from the chimney at the cricket and on the eave overhanging the area that was once the garage. Additionally a kick out flashing is recommended at the rear wall to roof transition to prevent water running down the wall. A qualified roofer is recommended for repairs.
- (2) Flashing repair is also recommended at the gutter at the bottom of the rear valley. Rotted fascia is present indicating water build up. A qualified roofer is recommended for repair.

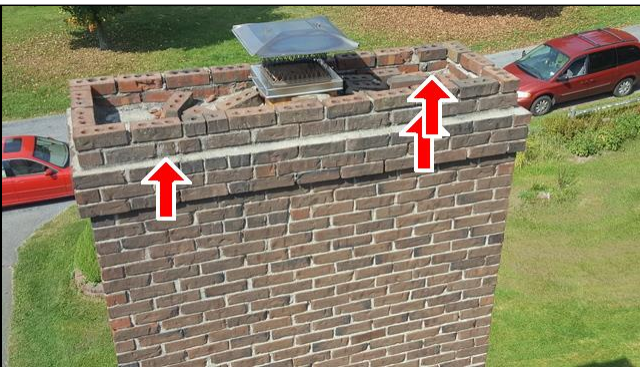
1.2 Item 1(Picture) Deteriorated mortar and loose bricks

Deteriorated mortar and loose bricks were noted at the top of the chimney. Repair is recommended by a masonry repair professional.

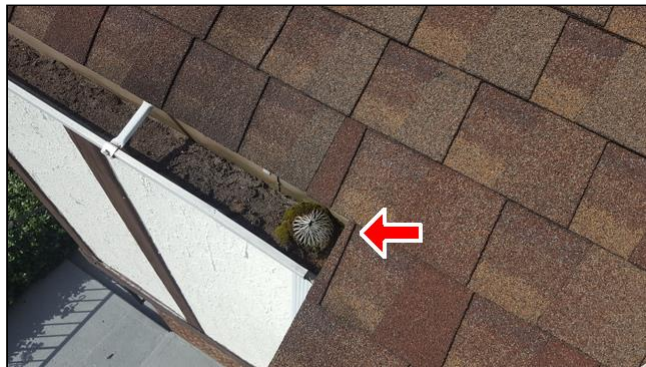
1.3 Item 1(Picture) Clogged

The gutter downspout screens are clogged in areas. Maintenance is recommended to insure proper function. A qualified person should perform the maintenance.

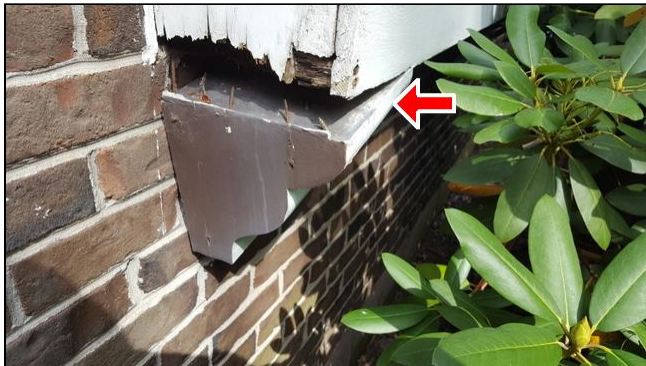
2.0 Item 1(Picture) Rotted trim

- (1) The exterior wood trim needs paint maintenance in most areas. Peeling deteriorated paint was noted throughout the exterior. Rotted and water damaged trim was noted in several areas. Repair of deteriorated wood is recommended along with paint maintenance to prevent further deterioration. A qualified professional is recommended.
- (2) Minor cracking was noted in the stucco exterior. Maintenance is recommended by a qualified professional to prevent further damage.
- (3) Mortar cracking and rusted lintels were noted near the old garage entry door. Repair is recommended by a qualified professional to prevent further deterioration.

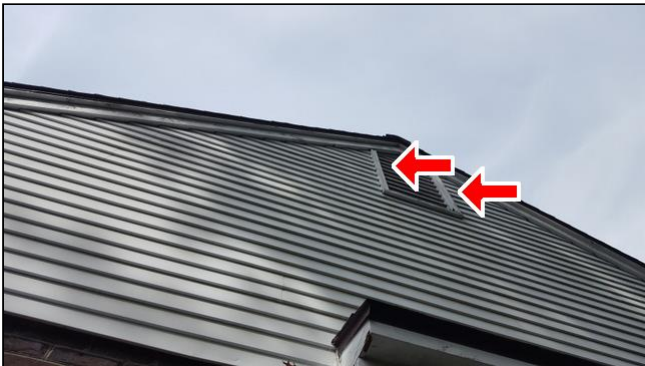
2.0 Item 2(Picture) Trim needs paint

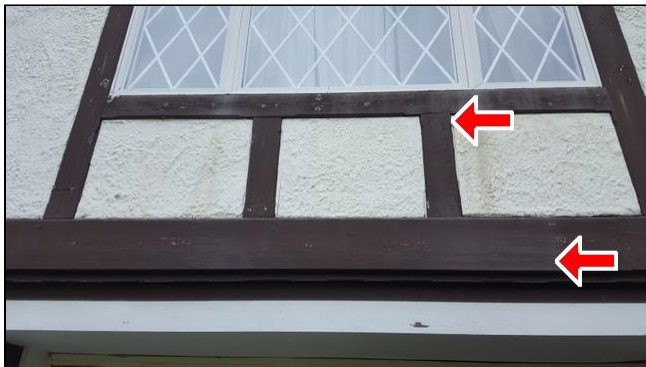
2.0 Item 3(Picture) Paint trim

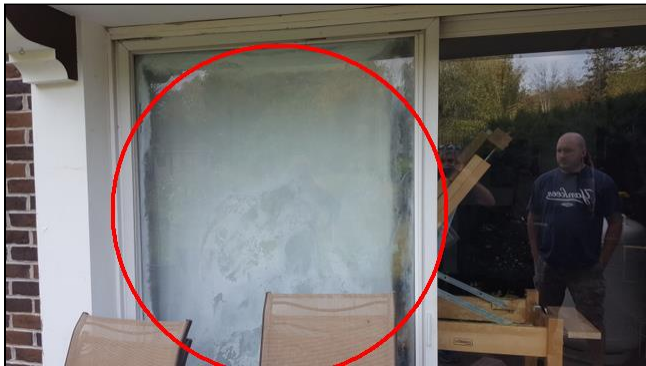
2.1 Item 1(Picture) Broken thermal seal

The lower level sliding glass door was noted with a broken thermal seal. This condition may cause heat loss in the winter. Repair as needed using a qualified professional.

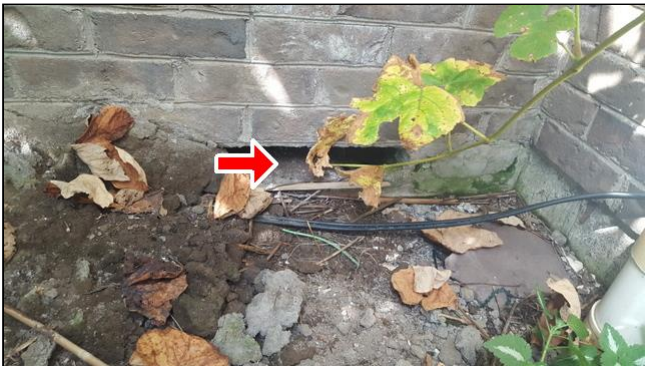
2.3 Item 1(Picture) Missing block at foundation

- (1) Missing foundation block, cracked concrete and brick were noted on the right side of the front porch. Repairs are recommended by a masonry/concrete repair professional to prevent further damage.
- (2) The front porch stairs have a negative slope that drains towards the house. Water infiltration may occur in this area. Repair/correct as needed using a concrete repair professional

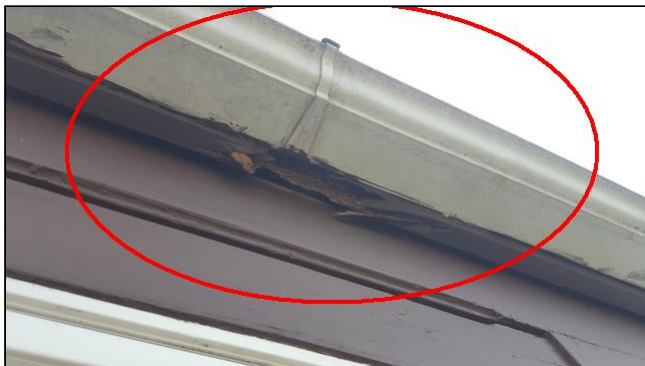
Rotted fascia was noted on the left side and rear wall to roof transition. Repair is recommended by a carpenter or other qualified person to prevent further damage.

2.5 Item 1(Picture) Rotted fascia

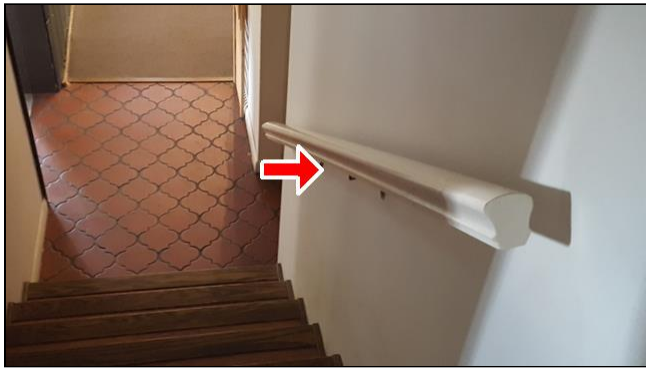
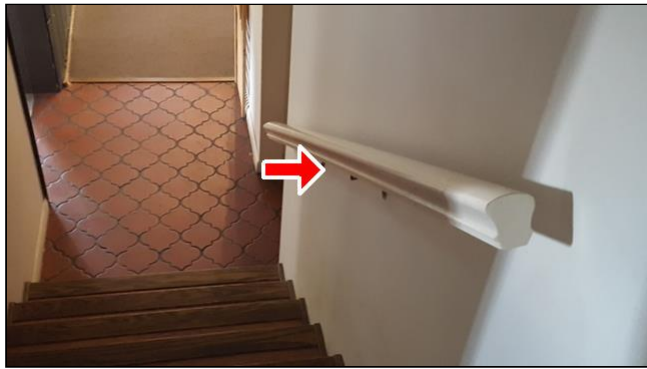
3.3 Item 1(Picture) Loose handrail

A loose handrail was noted leading to the finished lower level.

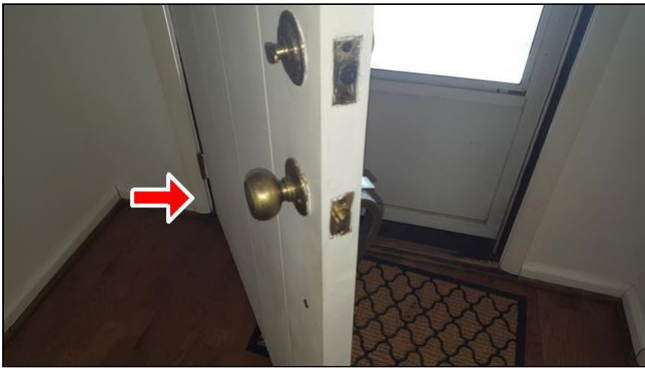
3.5 Item 1(Picture) Repair needed

The front door knob does not operated as intended. Repair by a qualified person is recommended.

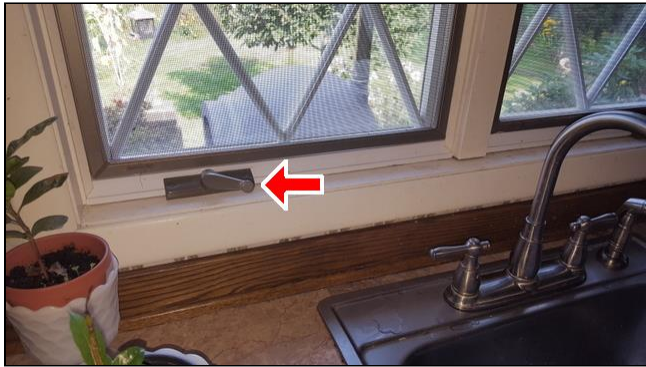
3.6 Item 1(Picture) Not operable

Casement windows were noted with missing hardware, loose hardware and inoperable in multiple locations. Most windows were also difficult to open and need lubrication. A qualified window repair professional is recommended to make necessary repairs.

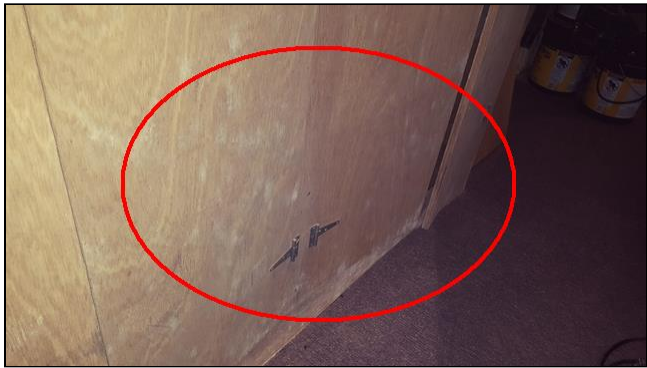
Mold growth was noted on shelving, cabinets and other surfaces in the basement. Elevated humidity was detected and appears to be the cause of the mold growth. A dehumidifier(s) are recommended to prevent further growth. Professional remediation may be considered for mold removal.

4.0 Item 1(Picture) Mold on cabinet

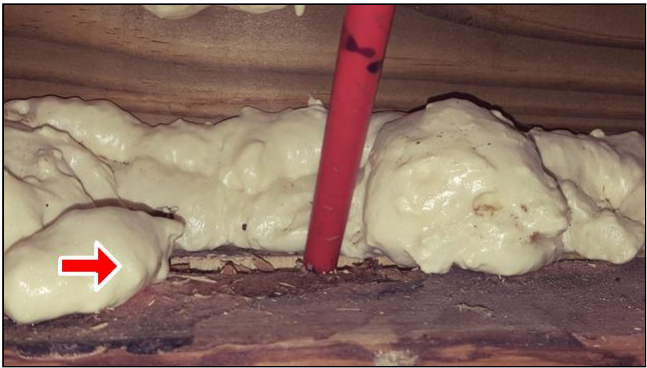
Rotted sill plate and wood destroying insect damage was noted in the basement below the kitchen sliding door. Repair have been made, possibly to correct water intrusion. A pest control professional is recommended to provide treatment options. Repair of the rotted wood should be considered, as settling may occur at the rotted areas. A carpenter should be consulted for repair suggestions.

4.3 Item 1(Picture) Rotted sill plate

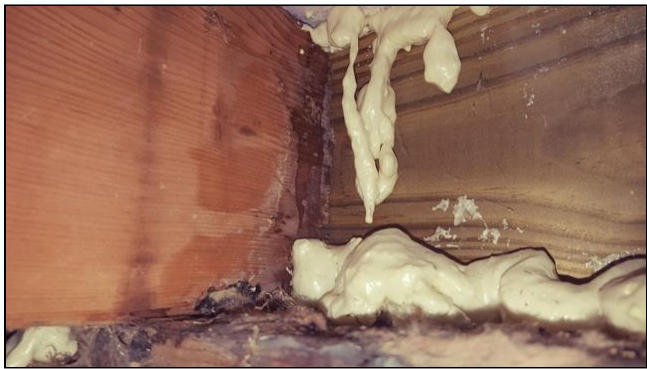
4.3 Item 2(Picture) Rotted joist and sill plate

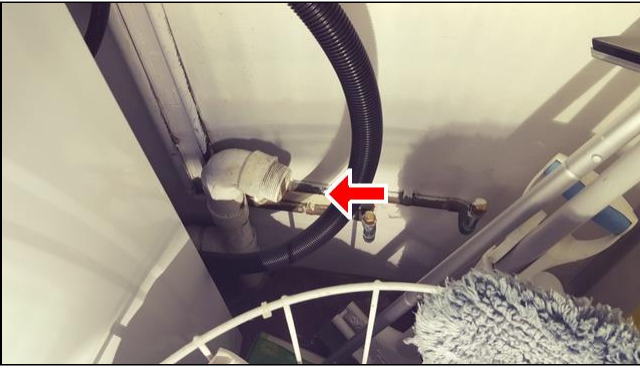
- (1) An interior main sewer drain clean out access was not observed in the home. A plumber or other qualified person is recommended to install a clean out in case the main line needs to be cleared.
- (2) An unused open trap was noted in the basement below the kitchen and behind the washing machine. Additionally a drain line was noted running under the dining room, but no fixtures are present in that area. The open trap started gurgling when the dishwasher was draining. A plumber or other qualified person is recommended to make repairs necessary to insure no open drains area present and fixture are draining properly.

5.0 Item 1(Picture) Open drain line

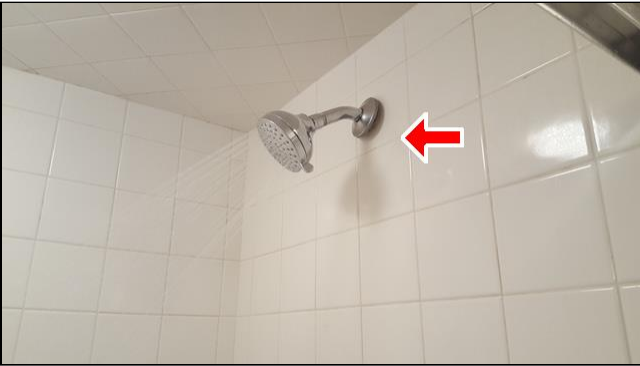
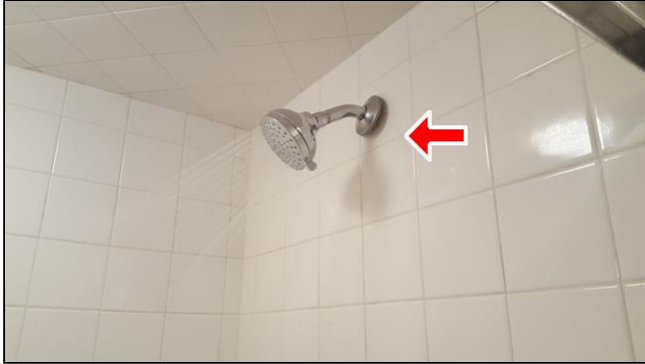
5.1 Item 1(Picture) Loose shower arm

(1) The shower arm in the master bathroom is loose. Repair will likely require opening the wall. A qualified professional is recommended for repair to prevent damage to the supply line and water leaks.

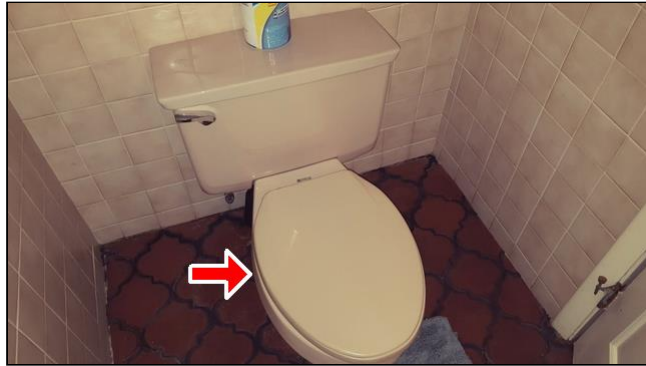
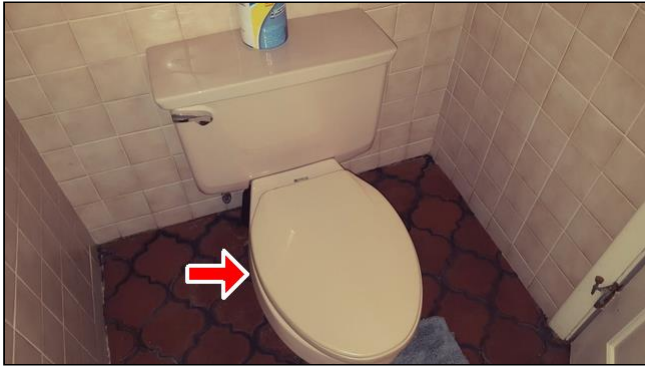
5.1 Item 2(Picture) Loose and leaks

(2) The lower level toilet is loose at the base and leaks. Repair by a plumber is recommended.

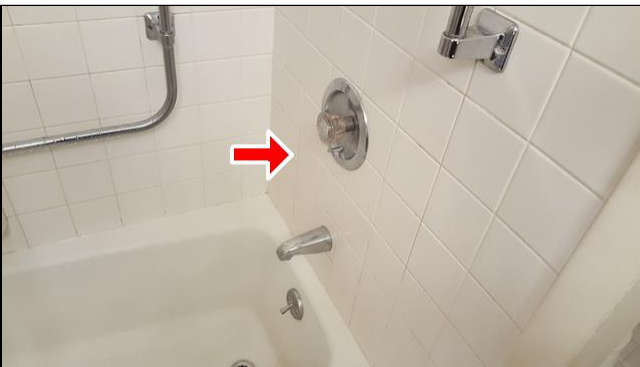
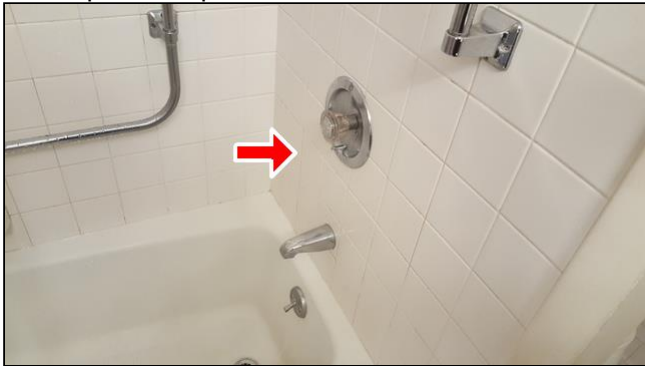
5.1 Item 3(Picture) Tub diverter not working

(3) The tub diverter in the hall bathroom is not functional. Repair is recommended by a plumber or other qualified professional.

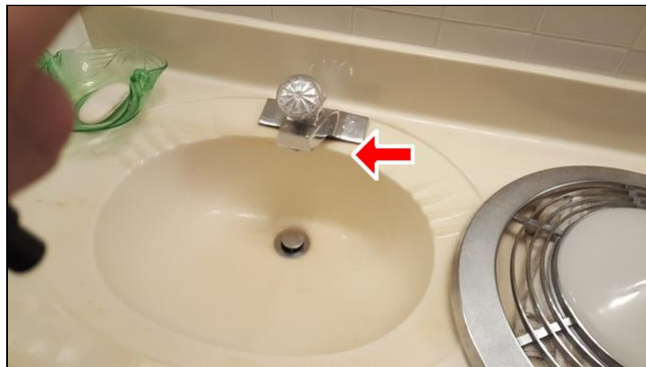
- (1) The shower arm in the master bathroom is loose. Repair will likely require opining the wall. A qualified professional is recommended for repair to prevent damage to the supply line and water leaks.
- (2) The lower level toilet is loose at the base and leaks. Repair by a plumber is recommended.
- (3) The tub diverter in the hall bathroom is not functional. Repair is recommended by a plumber or other qualified professional.
- (4) The master bathroom sink stopper is not functional. The aerators on the hall bath sinks appears to need repair or replacement. One aerator is restricted and the other puts out too much water that spills out of the sink when operated.

5.1 Item 4(Picture) Too much water

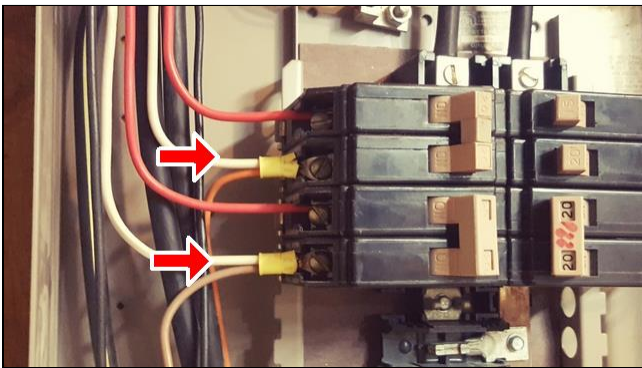
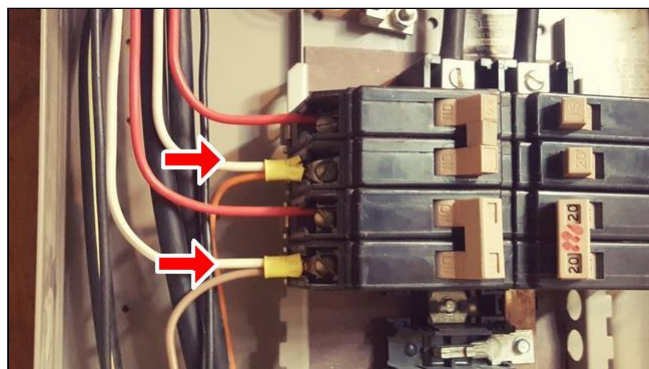
6.1 Item 1(Picture) Double tapped breakers

Double tapped breakers were noted in the sub panel located in the basement. A electrician is recommended to correct appropriately.

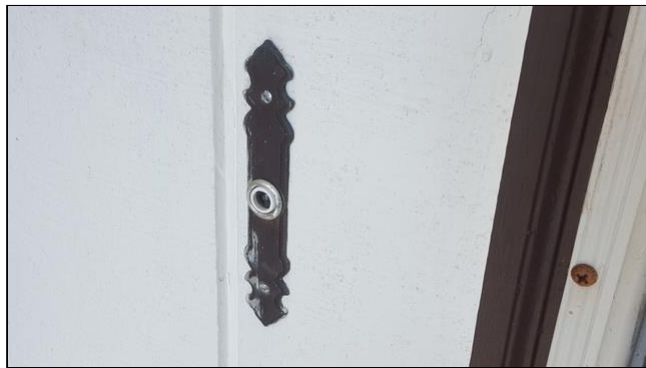
6.3 Item 1(Picture) not functional

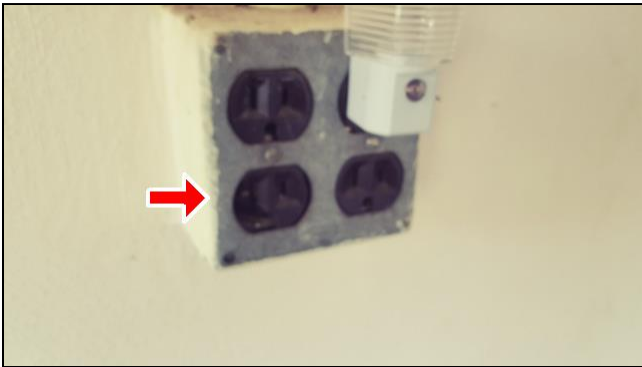
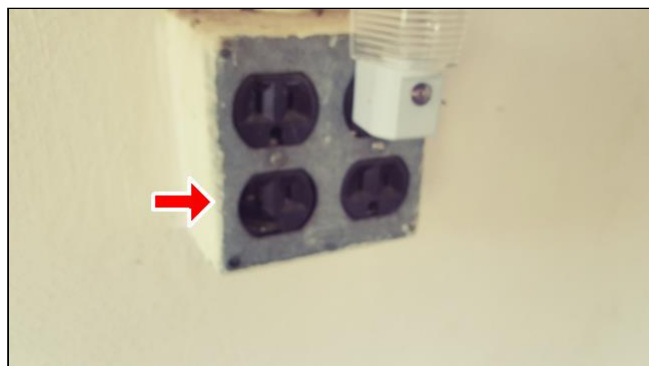
6.3 Item 2(Picture) Broken outlet

- (1) The front door bell is not functional. Repair or replace as needed.
- (2) A broken outlet was noted in the converted garage.

All items are recommended for repair by an electrician.

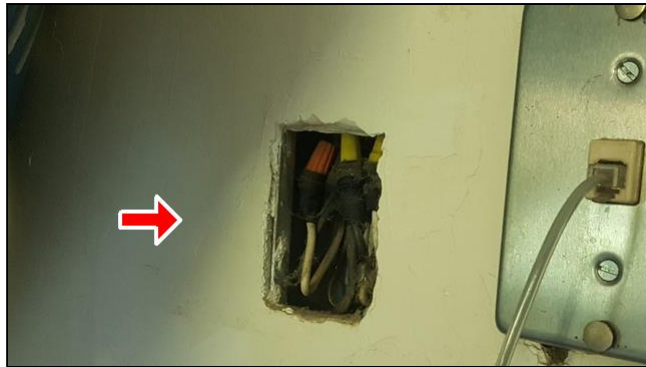
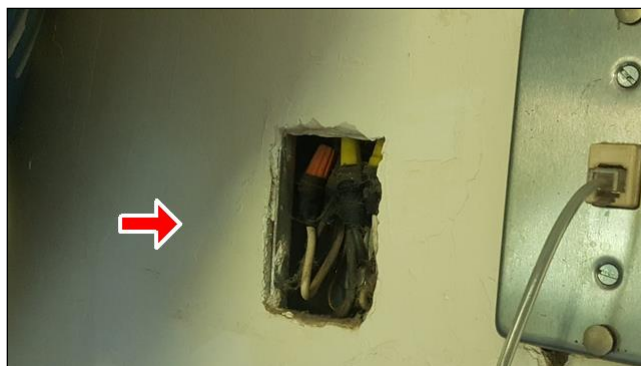
6.3 Item 3(Picture) Uncovered junction box

A uncovered junction box was observed in the kitchen near the light switches.

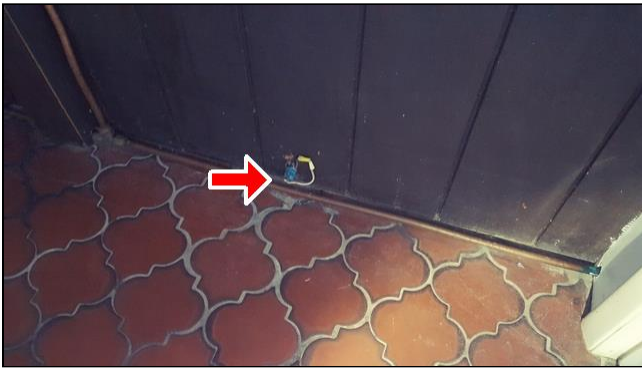
6.3 Item 4(Picture) Exposed wires

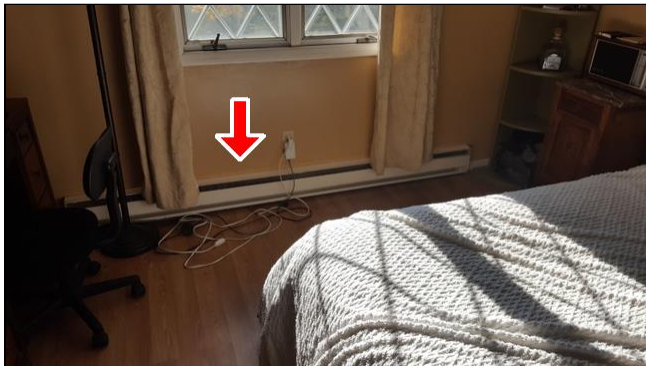
7.0 Item 1(Picture) Baseboard heater not operational

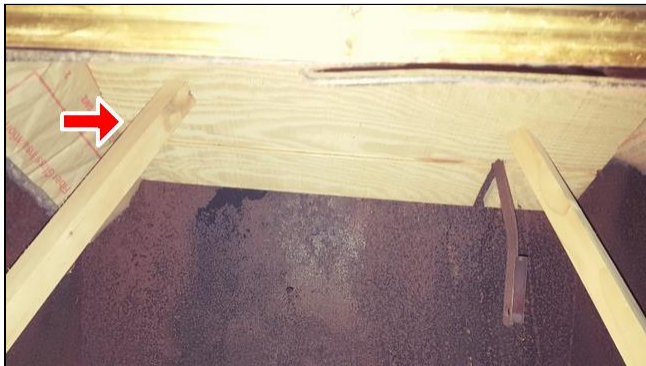
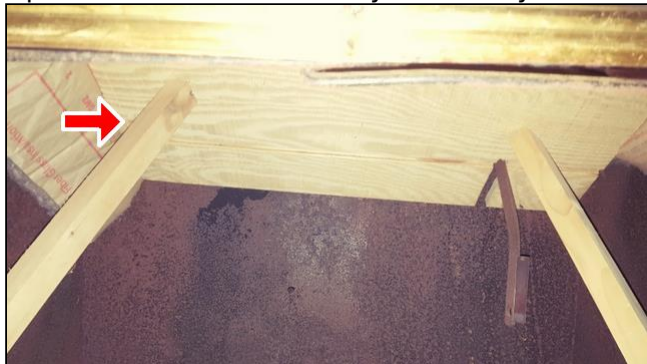
7.6 Item 2(Picture) Flue blocked

(2) The wood fireplace located in the lower level has wood blocking the flue. Cleaning and necessary repairs are recommended by a chimney service professional prior to use.

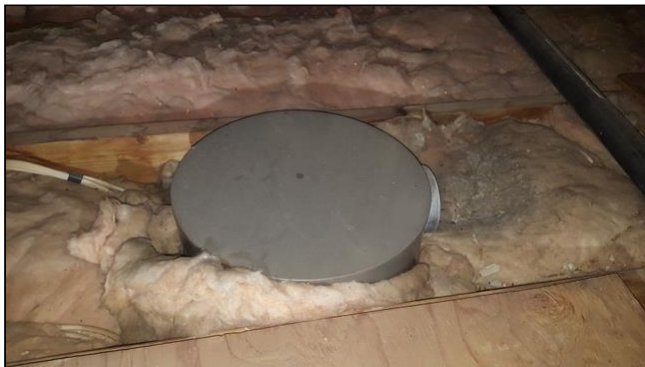
- (1) The hall, master and kitchen vent fans terminate into the attic. Terminating all exhaust fans to the exterior is recommended. A qualified professional is recommended to correct.
- (2) The cover is missing from the hall bath fan. Repair as needed.

8.4 Item 1(Picture) Bath fan

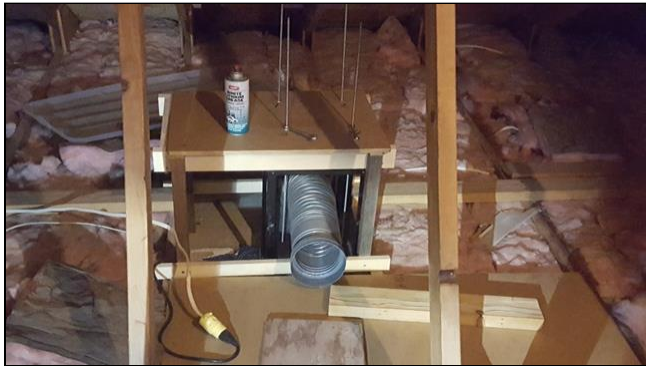
8.4 Item 2(Picture) Kitchen fan

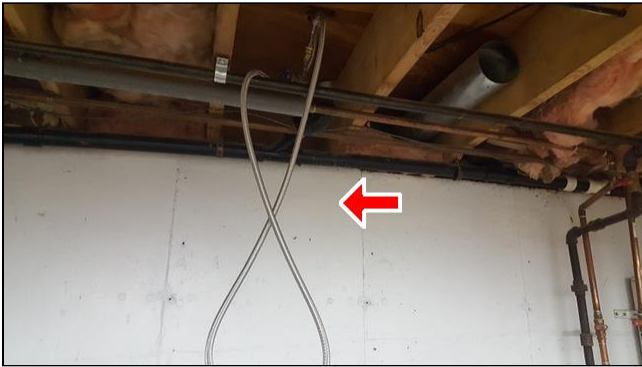
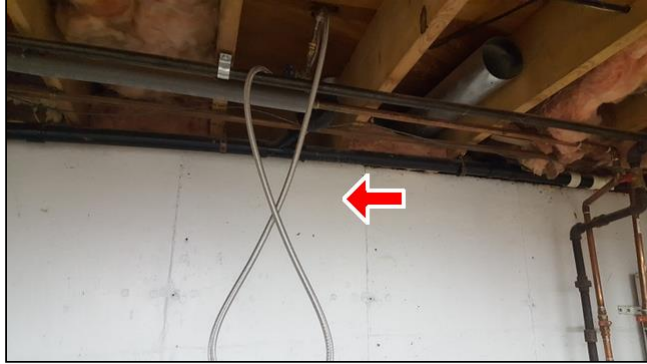
9.0 Item 1(Picture) Supply line

The dishwasher supply line is not properly restrained in the basement. A qualified person is recommended to restrain.

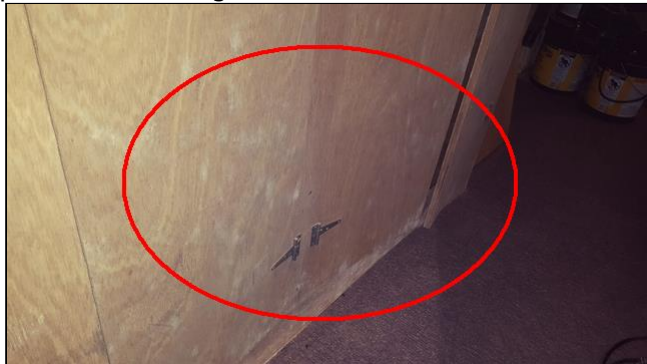
4.0 Item 1(Picture) Mold on cabinet

Mold growth was noted on shelving, cabinets and other surfaces in the basement. Elevated humidity was detected and appears to be the cause of the mold growth. A dehumidifier(s) are recommended to prevent further growth. Professional remediation may be considered for mold removal.

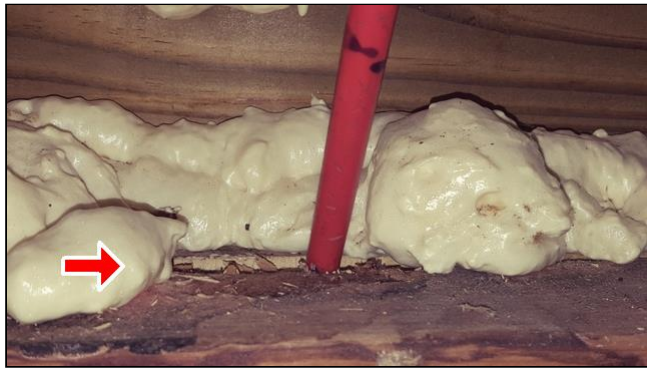
4.3 Item 1(Picture) Rotted sill plate

Rotted sill plate and wood destroying insect damage was noted in the basement below the kitchen sliding door. Repair have been made, possibly to correct water intrusion. A pest control professional is recommended to provide treatment options. Repair of the rotted wood should be considered, as settling may occur at the rotted areas. A carpenter should be consulted for repair suggestions.

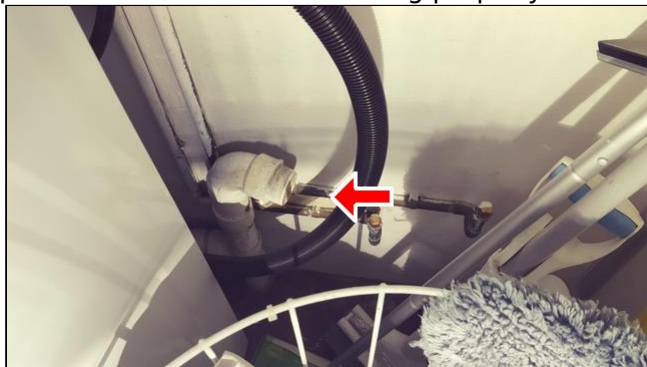
5.0 Item 1(Picture) Open drain line

- (1) An interior main sewer drain clean out access was not observed in the home. A plumber or other qualified person is recommended to install a clean out in case the main line needs to be cleared.
- (2) An unused open trap was noted in the basement below the kitchen and behind the washing machine. Additionally a drain line was noted running under the dining room, but no fixtures are present in that area. The open trap started gurgling when the dishwasher was draining. A plumber or other qualified person is recommended to make repairs necessary to insure no open drains area present and fixture are draining properly.

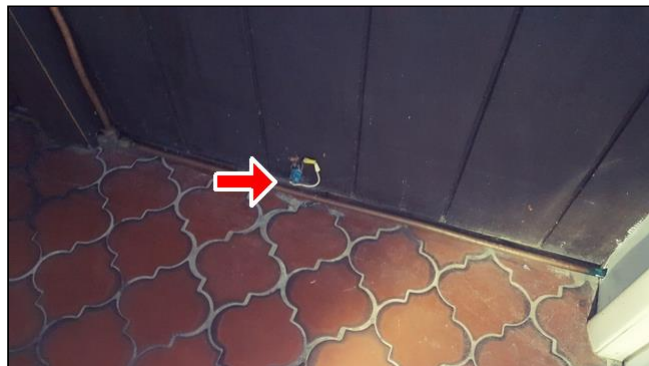
6.3 Item 4(Picture) Exposed wires

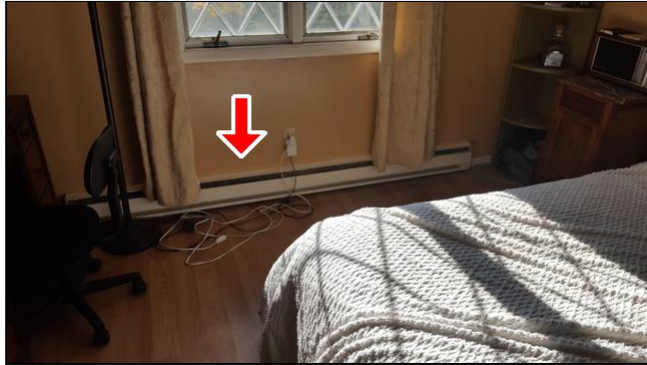
7.0 Item 1(Picture) Baseboard heater not operational

The electric baseboard heater in the front right bedroom was not operational at the time of inspection. Repair is recommended by an electrician or other qualified professional.

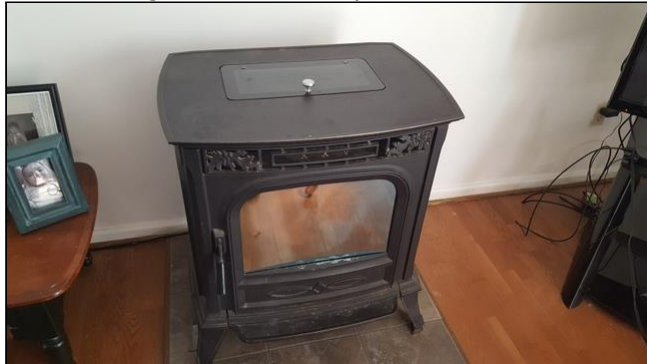
7.6 Item 1(Picture)

(1) Cleaning of both wood pellet stoves is recommended by a qualified professional prior to use.
